HUD Engineering Certification Report

As requested, we have evaluated the site conditions and foundation of the existing manufactured home for conformance with the Permanent Foundation Guide for Manufactured Housing; September, 1996. The purpose of this evaluation is for the resale, purchase, financing, or refinancing of the home. Our investigation and evaluation has been based on a visual review of the readily accessible areas of the foundation and overall surrounding site. The scope of the inspection included the foundation of the house.

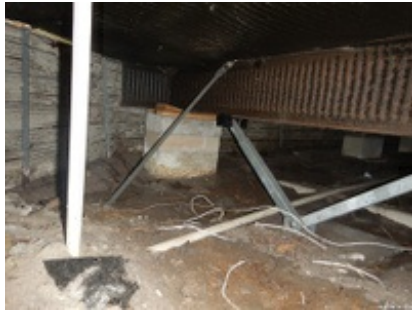
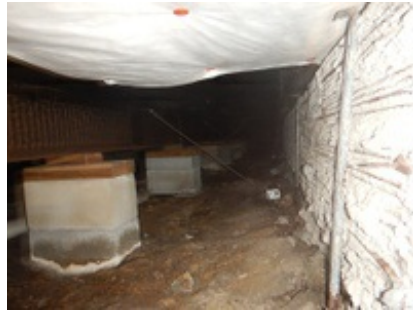
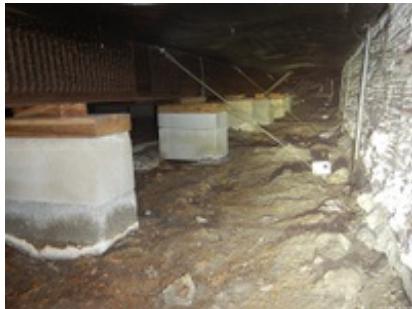
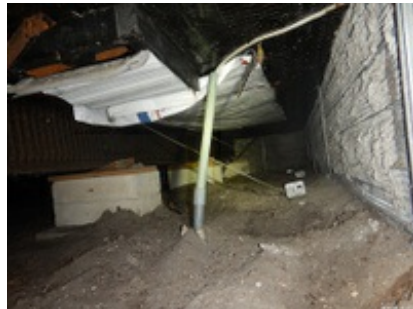
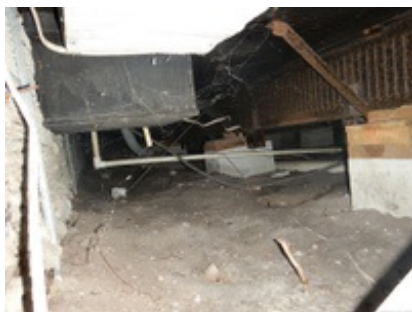
1.16 Foundation Type Images

Crawlspace

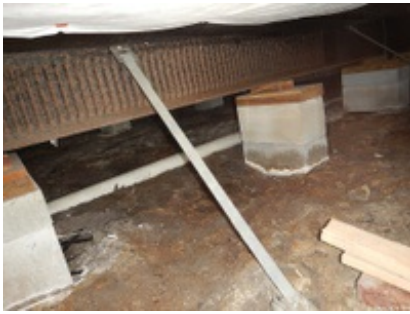
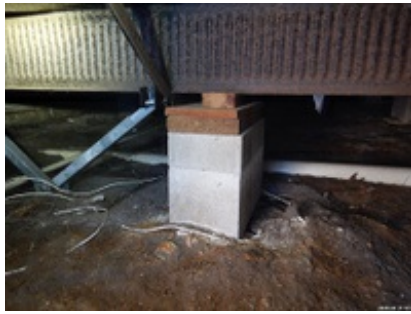
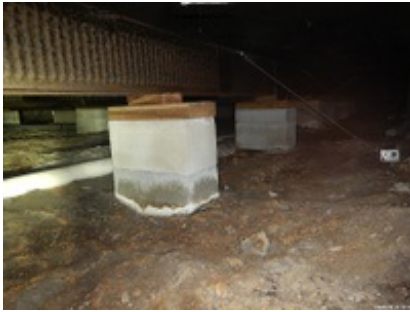
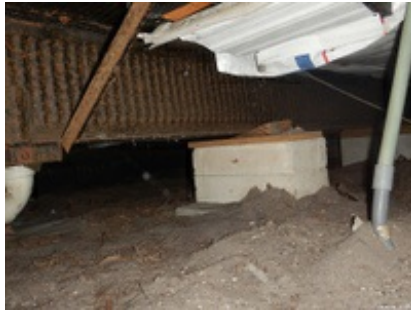
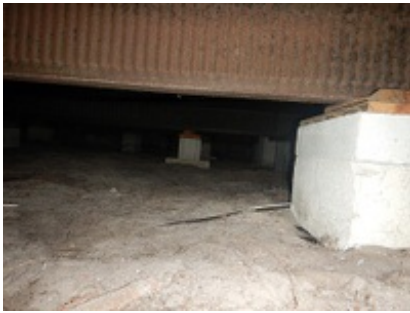
1.18 Piers Images

Dry-stacked Masonry Blocks

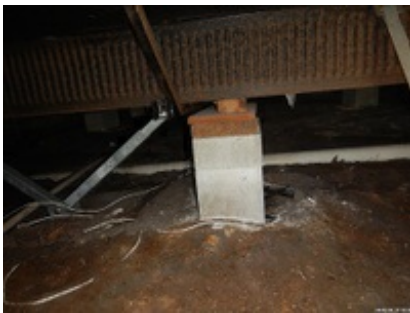
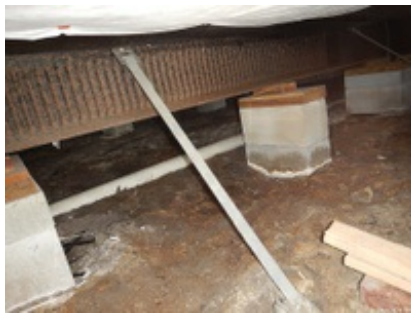
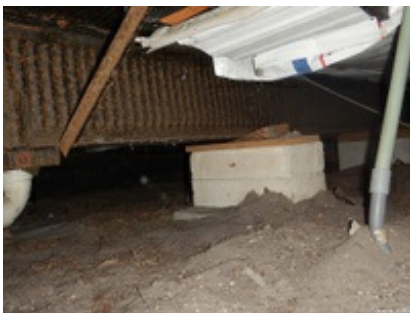
1.20 Piers Rest On Images

Masonry block and ABS pier base

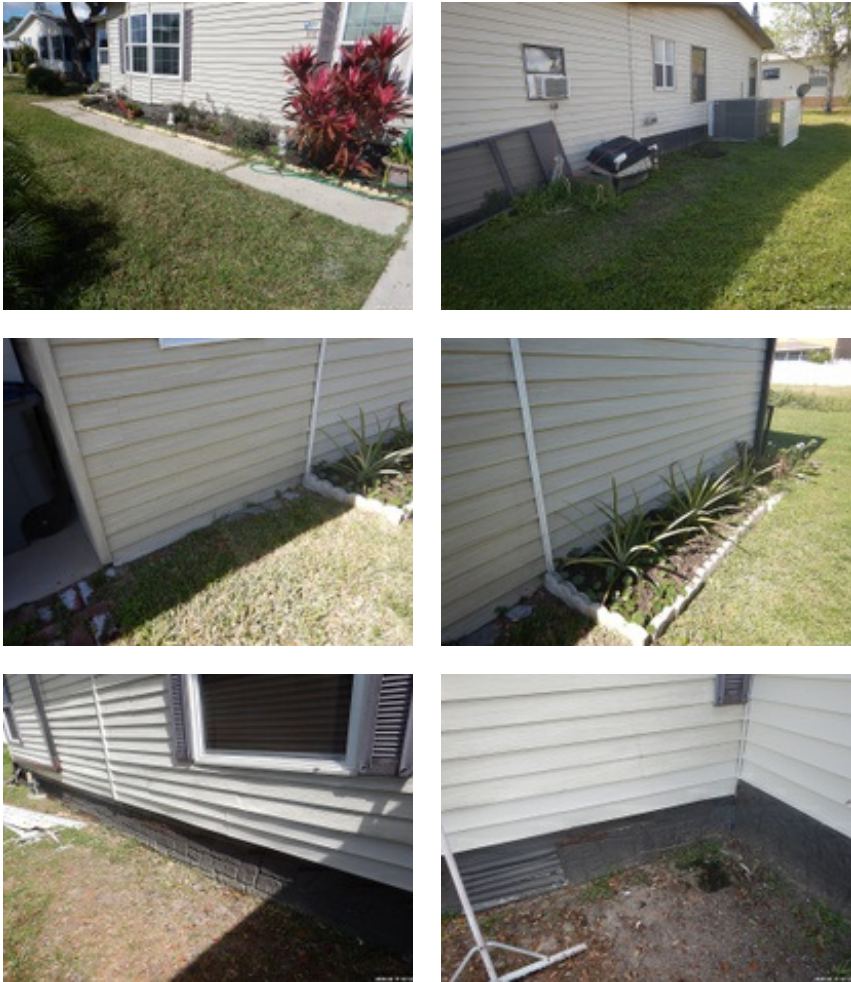
2.2 Exterior Grading Images

Grading is flat but no adverse conditions were noted.

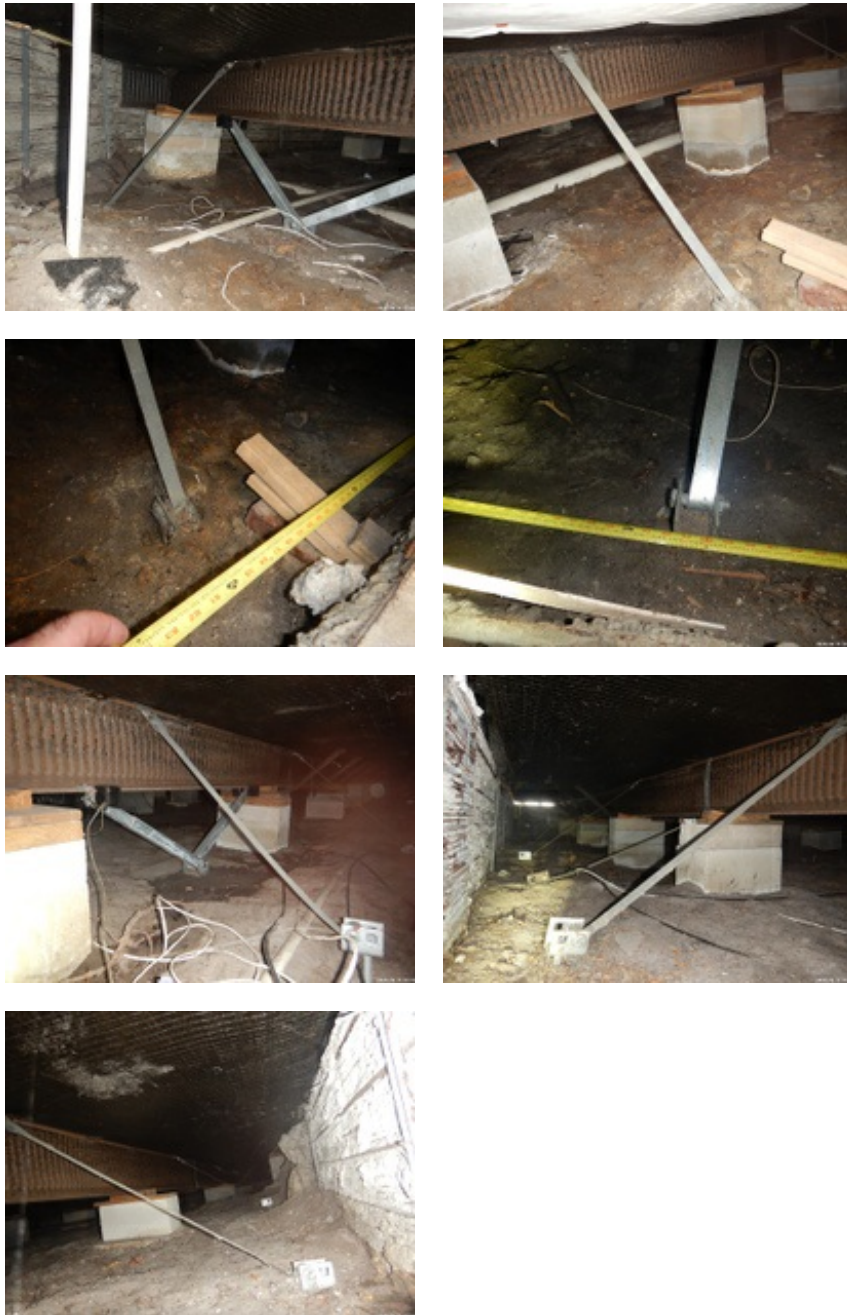
2.5 Anchor Method Images

Metal Straps connected to anchors augured into the soil

5'
